Bearing Failures

This presentation is mainly for wiped bearings...

...with causes related to assembly and alignment.

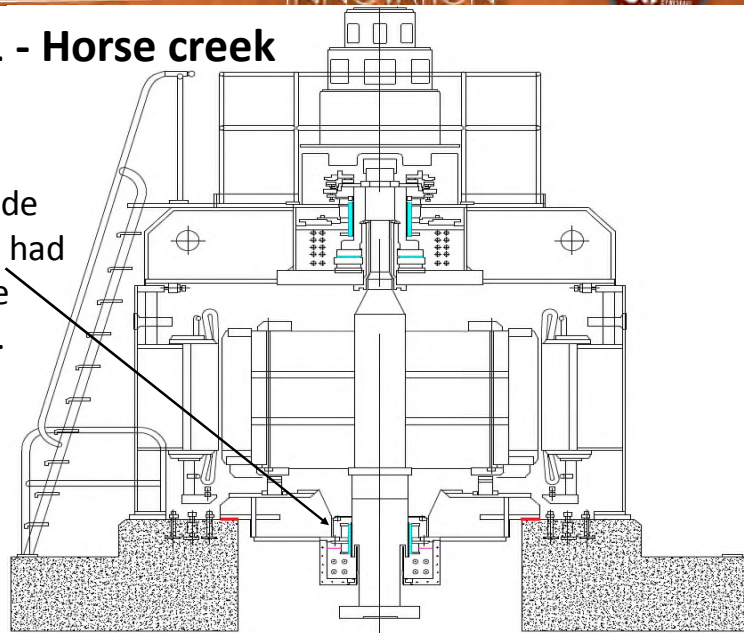
This guide bearing had multiple failures.
Why?

- 3 guide bearing failures at start-up
- Minor fixes had been done, but did not solve it
 - Bracket re-centering
 - Pole short-circuited turn fixed

- The most important correction for that project was to fix the flatness of the seating surface where the guide bearing is bolted, preventing unwanted distortion of the bearing.
- The fixed bearing ran for 25 years until 2012 when the unit was stopped for a major overhaul.

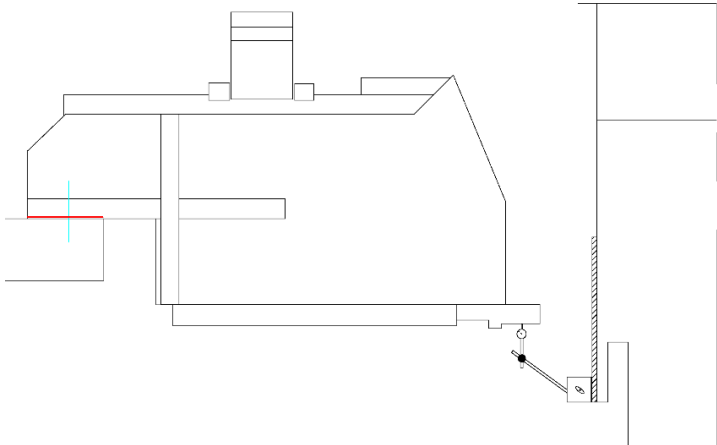
Perpendicularity and flatness check

- Verticality deviation 23 mils/ft !! (1.9 mm/m)
 - Not sufficient cause for bearing failure
- Stator / rotor concentricity 50 mils (2X CEATI tol.)
 - Create additional radial force
 - Not fixed for not worsening runner clearances
- Runout at TGB 17 mils (within CEATI tolerance)
 - Reduced at 9 mils as additional precaution
- Seating flange for LGB with flatness error of 7 mils

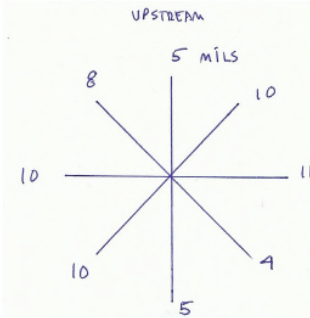
Perpendicularity and flatness check

Flatness error of 0.007 in.

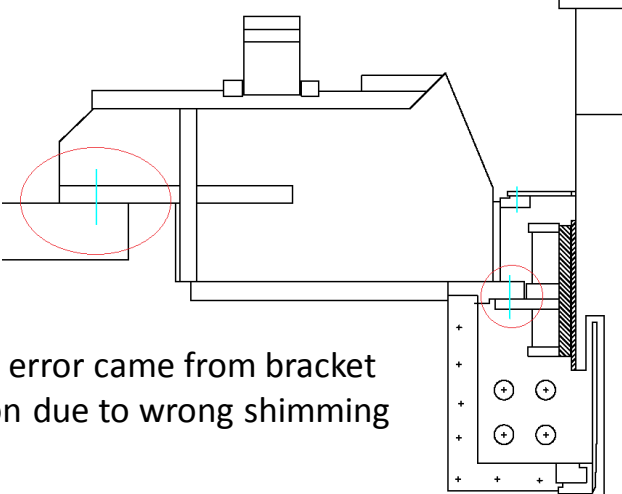
Flatness error came from bracket distortion due to wrong shimming

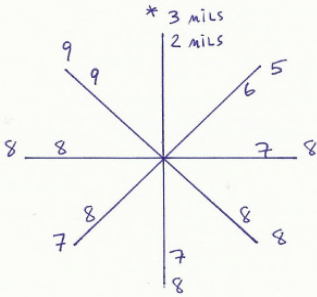
After correction of shims under bracket arms

Good perpendicularity and flatness within 3 mils

* Local surface defect corrected with a shim of 4 mils

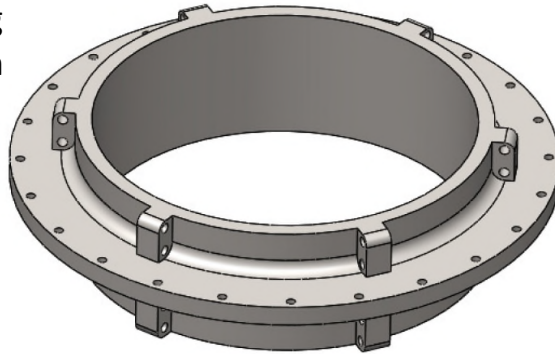
Shell type bearing
68" Dia x 25" high
In 6 sections

- Unit alignment checked and OK
 - ✓ Runout
 - ✓ Concentricity
 - ✓ Verticality
- Seating surface for Turbine Bearing, not OK
 - ✓ Flatness deviation of 0.014"

- If major overhaul, machining of stationary components probably required.
- For a repair, we added shims of different thicknesses around the circumference of the seating flange, to make it flat (within 0.005")
- That repaired bearing may possibly live for 30 years, and already ran for 13 years.

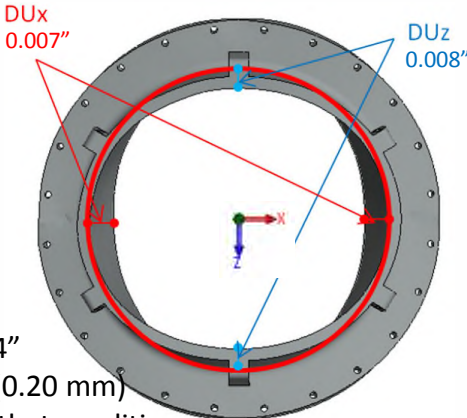
- Under axial deformation of 0.014"
- Babbitt face varies up to 0.008" (0.20 mm)
- Bearing not designed to work in that condition
- It takes only 3 tons or 1 bolt on each side to deform it.

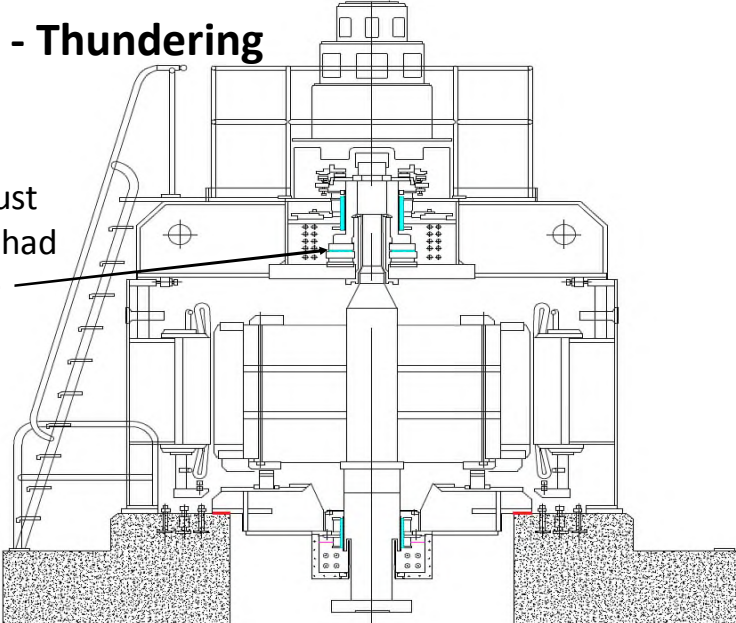
This thrust bearing had multiple failures.
Why?

- Repetitive bearing failure at start-up
- Bent surface under the thrust bearing base ring plate
 - flatness error of the order of 0.40 mm (0.016")
 - Leading to non-uniform loading of the bearing
 - Visible on wiped bearing pattern
- Recommended solution was to readjust shimming of the upper bracket legs, and control surface flatness.

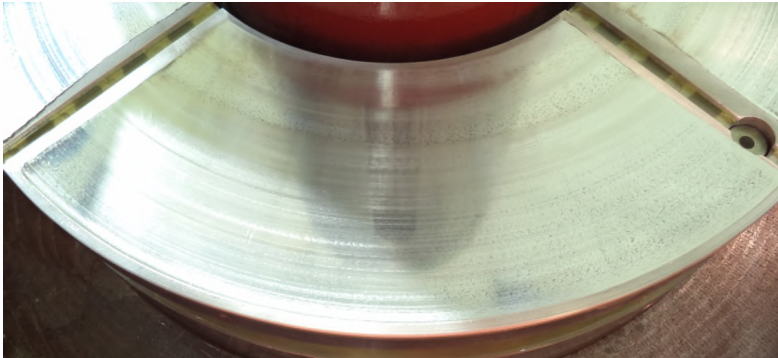
Babbitt wiped

- No change on alignment
- Minimum cut in Babbitt
- Hand scraping of the Babbitt surface
 - Rubbing against actual thrust collar assembly for finding high spots, instead of flat marble
- Redistribution of springs, shorter springs near edges
