Bearing Failures

This presentation is mainly for wiped bearings...

...with causes related to assembly and alignment.

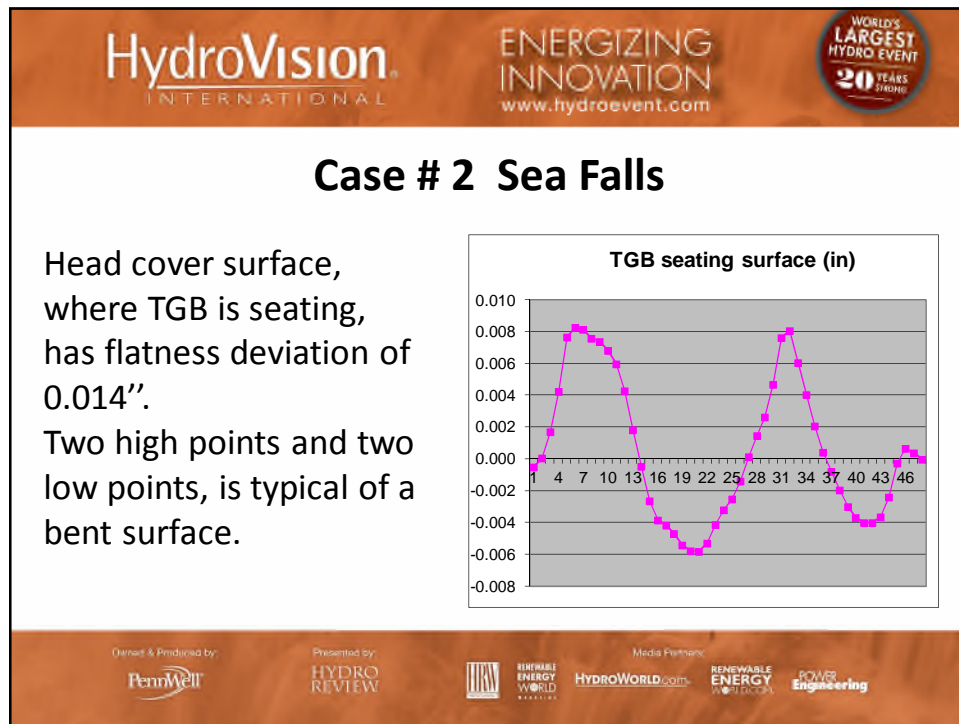
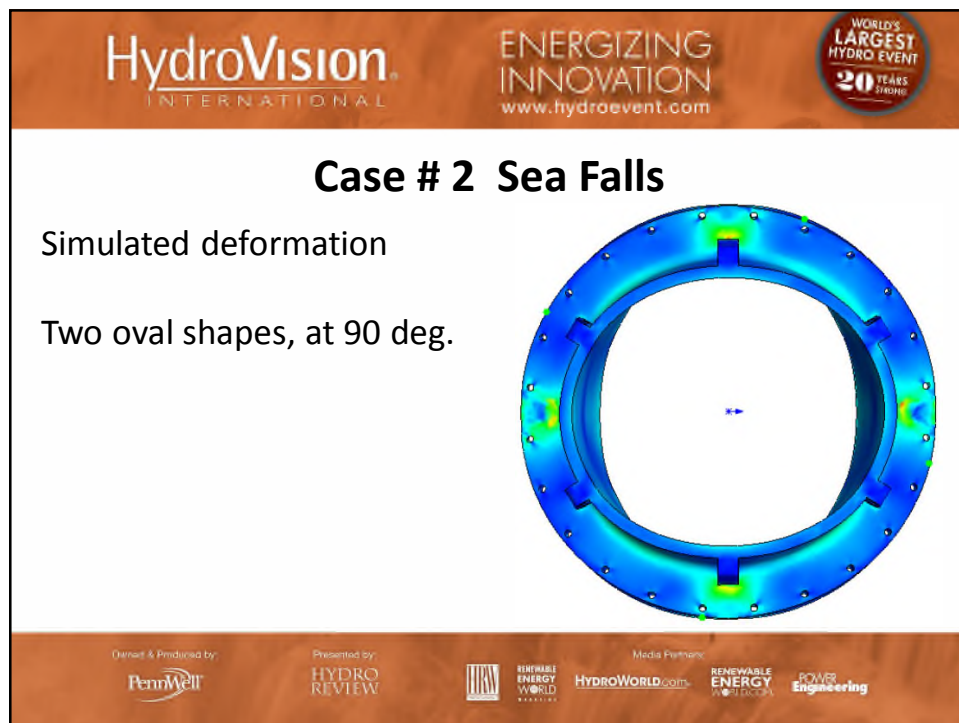
Case # 2 Sea Falls

Two high points
and two low points
around the
circumference

- Under axial deformation of 0.014"
- Babbitt face varies up to 0.008" (0.20 mm)
- Bearing not designed to work in that condition
- It takes only 3 tons or 1 bolt on each side to deform it.

- If major overhaul, machining of stationary components probably required.
- For a repair, we added shims of different thicknesses around the circumference of the seating flange, to make it flat (within 0.005")
- That repaired bearing may possibly live for 30 years, and already ran for 13 years.
